2017 Hurricane Harvey Deployment  
Arkema Facility Response  
8/31/2017 7:16:37 PM

***2017 ASPECT Preliminary Report  
Arkema Plant Response  
Crosby, TX***

***August 31, 2017  
0600 hrs to 1900 hrs***

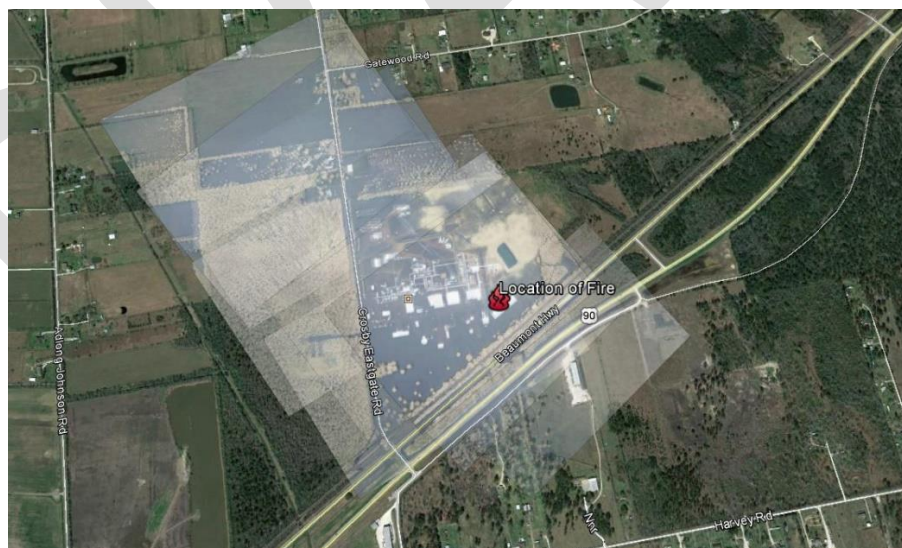
Figures 2 & 3 show a visible image of the facility with no observed plume and the flight path highlighted when IR sensors were active.

*Figure 2: Low resolution aerial images pulled from the aircraft while in flight over the facility, 30 August 2017 at about 0730 hrs CST.*

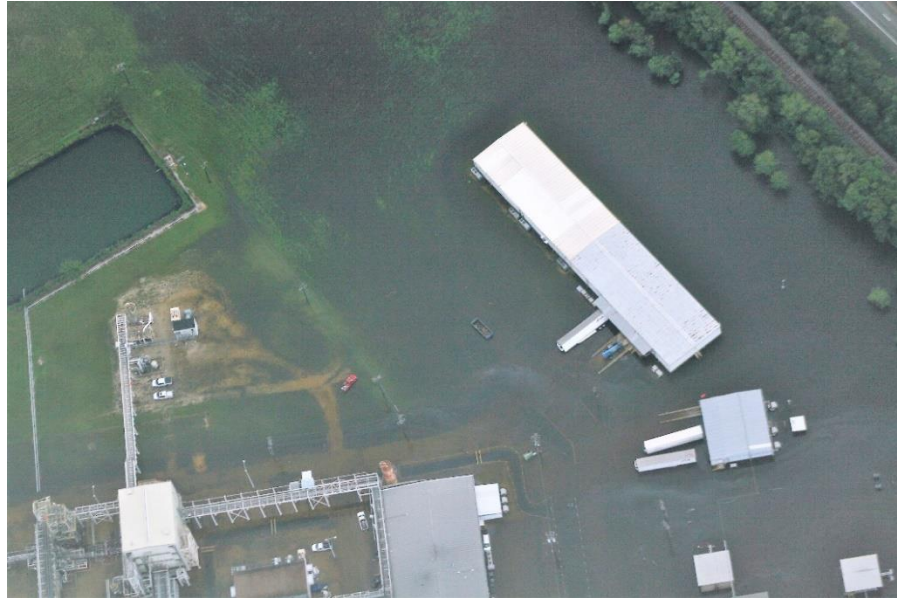
*Figure 3: Oblique photo prior to explosion/fire on 30 August 2017.*

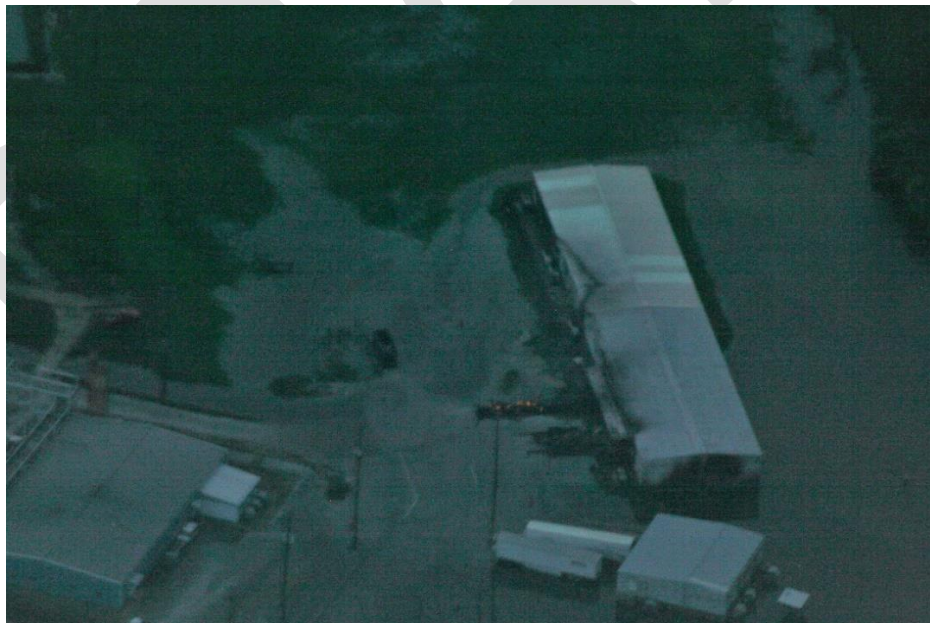
*Figure 4: Oblique photo after explosion/fire on 31 August 2017*

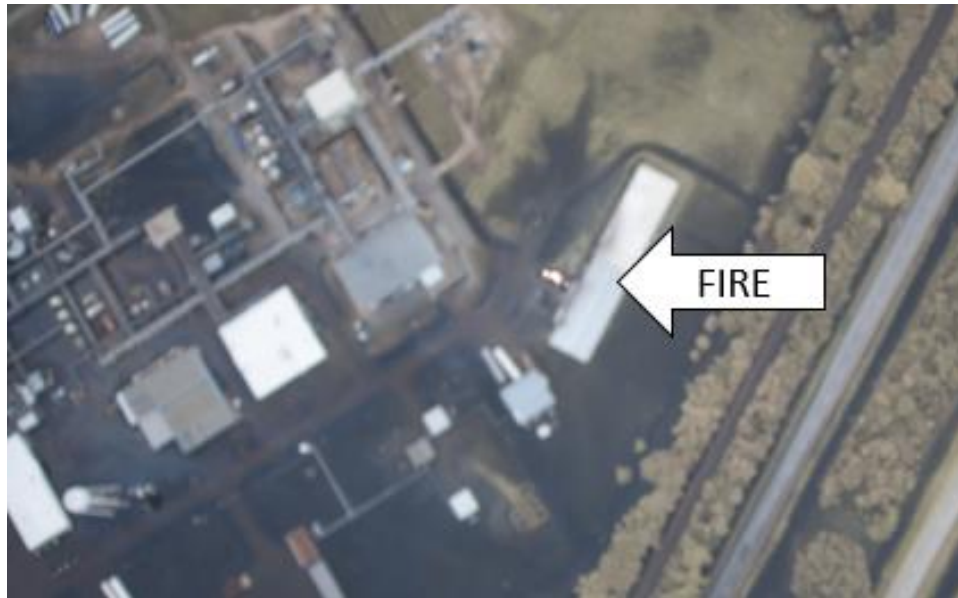
High-resolution aerial photos provide downward view of the area. Figure 5 has been enhanced due to poor visual conditions when the aircraft arrived on site. Foggy weather combined with low light conditions is reflected in this image.

*Figure 5: Aerial photo over the site captured during the morning flight on 31 August 2017.*

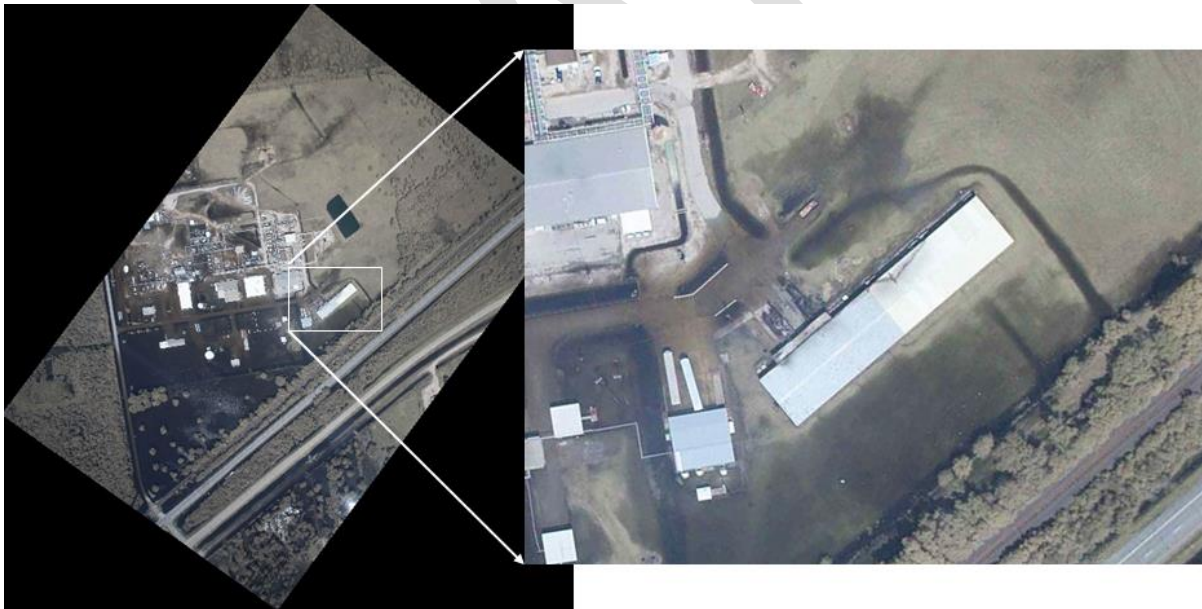
*Figure 6: Low resolution aerial image retrieved from the aircraft during the afternoon sortie, approximately 1335 hrs. A copy of the entire image will be provided in an email. A portion of the photo was enlarged to show the affected building.*

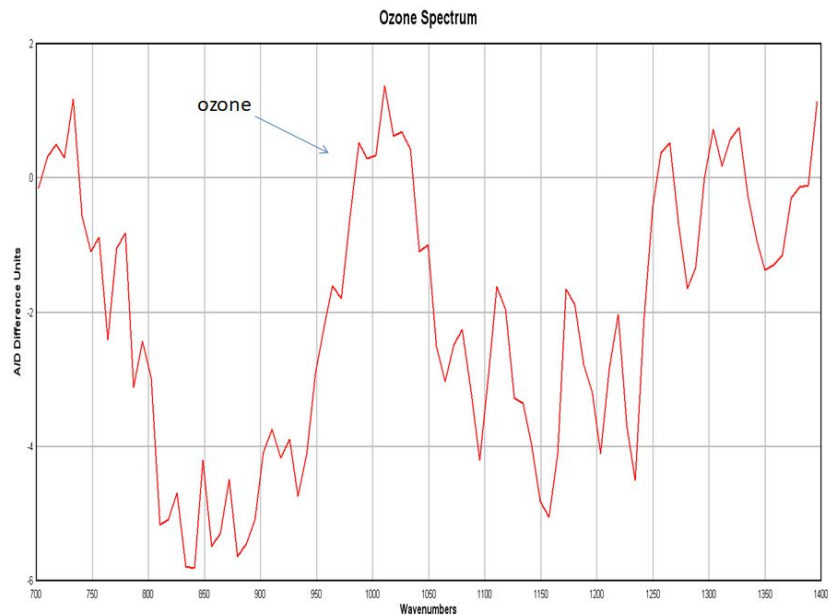
The ASPECT technical reach back team manually inspected and analyzed 21,000 FTIR spectral measurements from the morning sortie. No significant deviations or anomalies were associated with the explosion and subsequent fire, however ozone was detected which was likely created during the fire.

Figure 8: Passive (remotely detected at 2,800 ft AGL) FTIR spectra showing ozone, a commonly occurring air pollutant, but this measurement suggests that ozone is being generated by the fire (e.g., the spectral image shows that the ozone is hotter than the background). This also confirms that the instrument was operating properly.

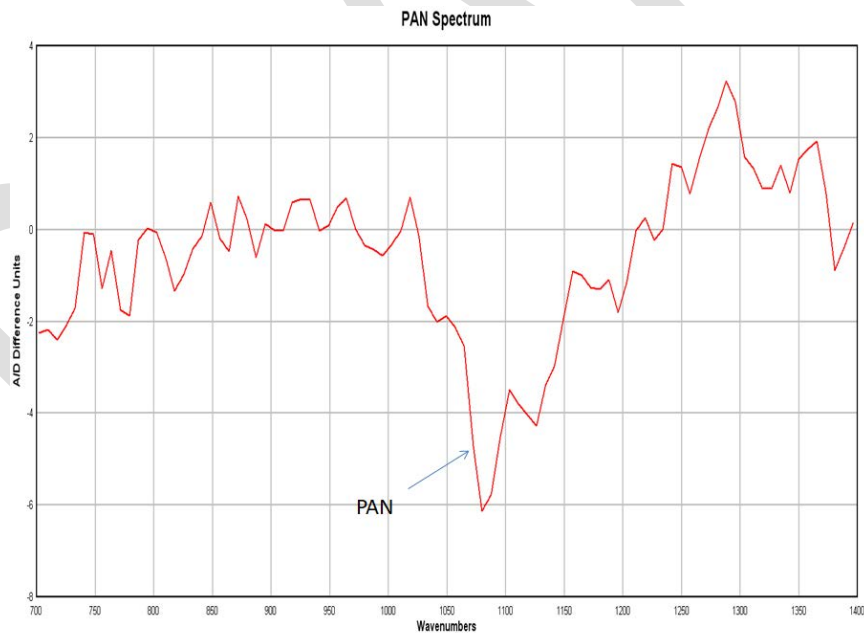
Figure 9: Passive (remotely detected at 2,800 ft AGL) FTIR spectra showing PAN (Peroxyacetyl nitrate), a commonly occurring air pollutant. This confirms that the instrument was operating properly.

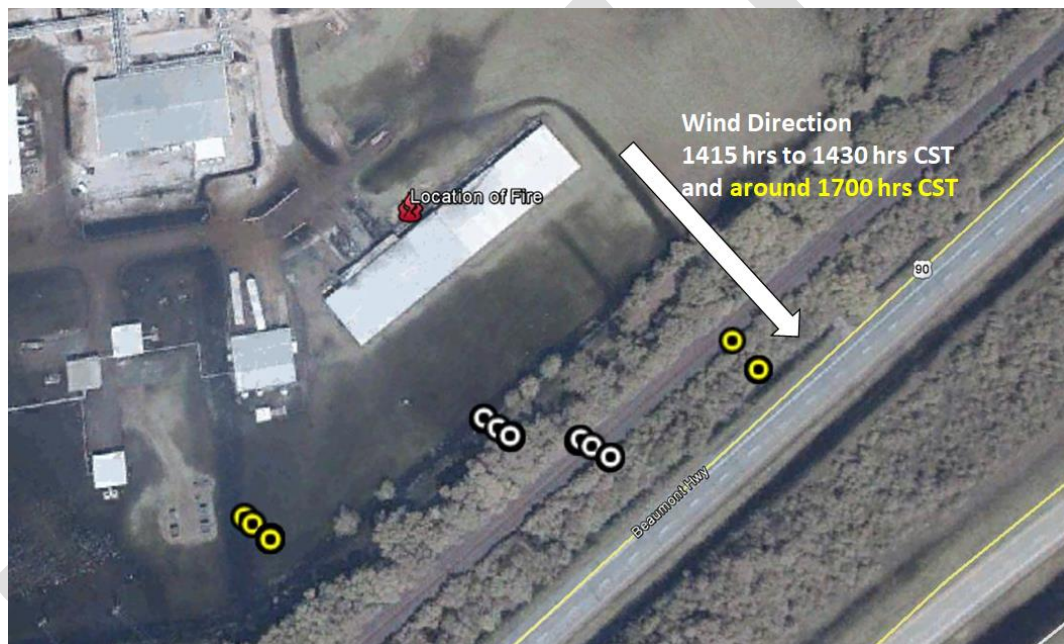
*Figure 10: Location of “weak” peroxide detections during ASPECT passes conducted between 1415 hrs and 1700 hrs. All detections are within the symbols shown in the image. Our collection frequency (70 measurements per second) caused many of the symbols to overlap. White dots collected during Flight 4. Yellow dots collected during Flight 5.*

1710 hrs and 1730 hrs ASPECT reported detections consistent with benzoyl peroxide over the site at approximately the same location shown in Figure 10.

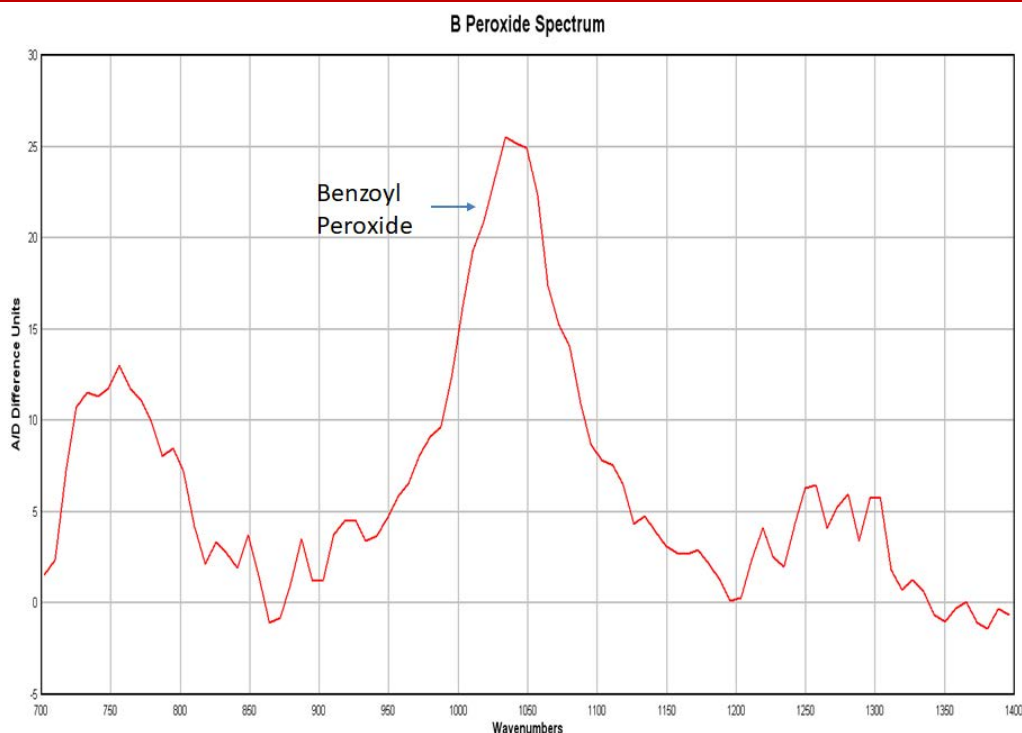
*Figure 11: FTIR spectra showing signature consistent with benzoyl peroxide vapors. The signature represents a typical spectra that exceeded our detection limit of about 5 ppm.*

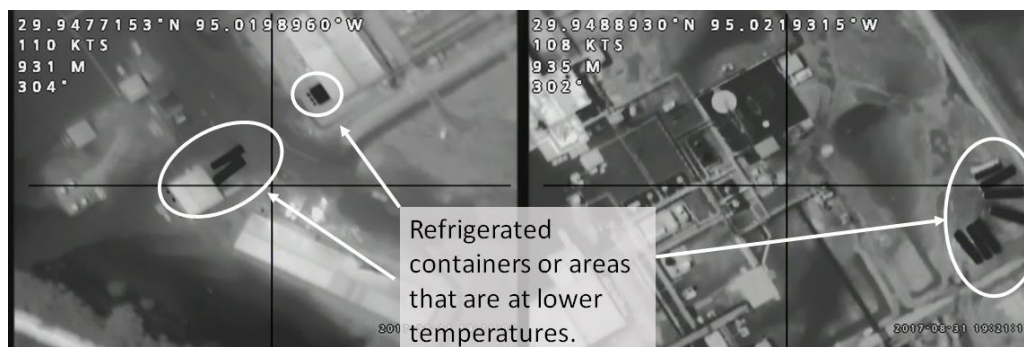
Figure 12 provides snap shots taken from an infrared video collected during the afternoon flight. Dark areas indicate lower temperatures. Eight tanks are identified in these images.

*Figure 12: Infrared images obtained from an infrared video (1320 hrs CST) clearly showing heat signatures which identifies which containers are cooled (black colors) at the Arkema facility. Note the northernmost tank in the image to the right. It is painted blue which may affect its heat signature. These photos show eight tanks that are being refrigerated.*
